Uniform Mitigation Verification Inspection Form

Inspection Date: 06/14/2021		
Owner Information		
Owner Name: Malachite at Sapphire Lakes Condo Association		Contact Person: Rigo
Address: 527 Joseph Court		Home Phone:
City: Naples	Zip: 34104	Work Phone:
County: COLLIER		Cell Phone:
Insurance Company:		Policy #:
Year of Home: 2001	# of Stories: 1	Email:

Malachite at Sapphire Lakes Condo Association:
527 Joseph built 2001

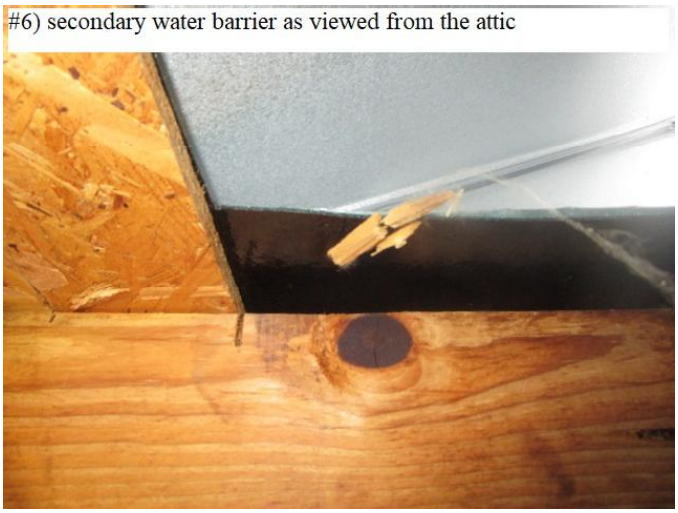
#6) secondary water barrier as viewed from the attic

#6) secondary water resistance

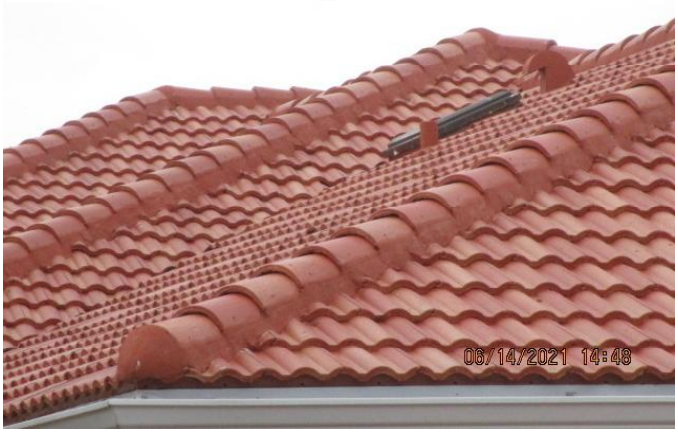
#2) roof covering: 2020 TILE HIP style roof
PRBD2020-0731307 applied 7/31/2020

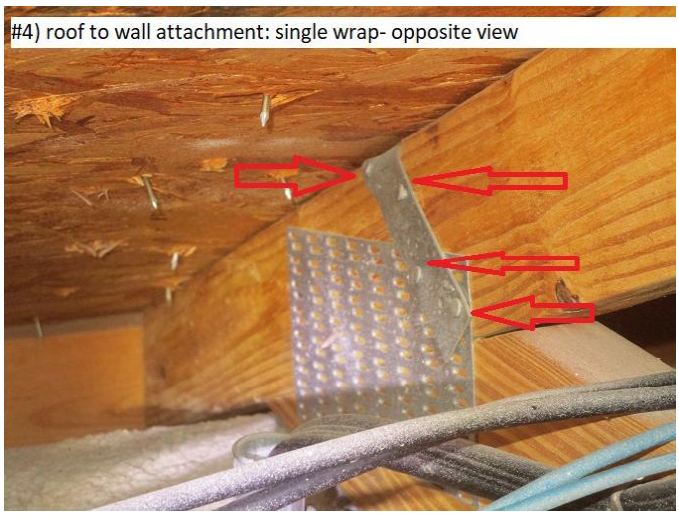
#4) roof to wall attachment: single wraps- front view
06/14/2021 11:40

#4) roof to wall attachment: single wrap- opposite view

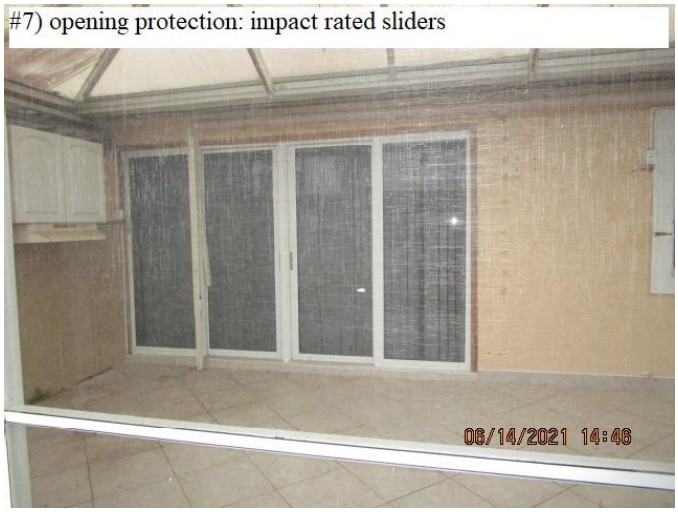
#7) opening protection: impact rated sliders

#7) opening protection: non impact rated sliders
